Debris/Ice/TPS Assessment And Photographic Analysis For Shuttle Mission STS-43

September 1991

DEBRIS/ICE/TPS ASSESSMENT
AND
PHOTOGRAPHIC ANALYSIS
OF
- SHUTTLE MISSION STS-43

August 2, 1991

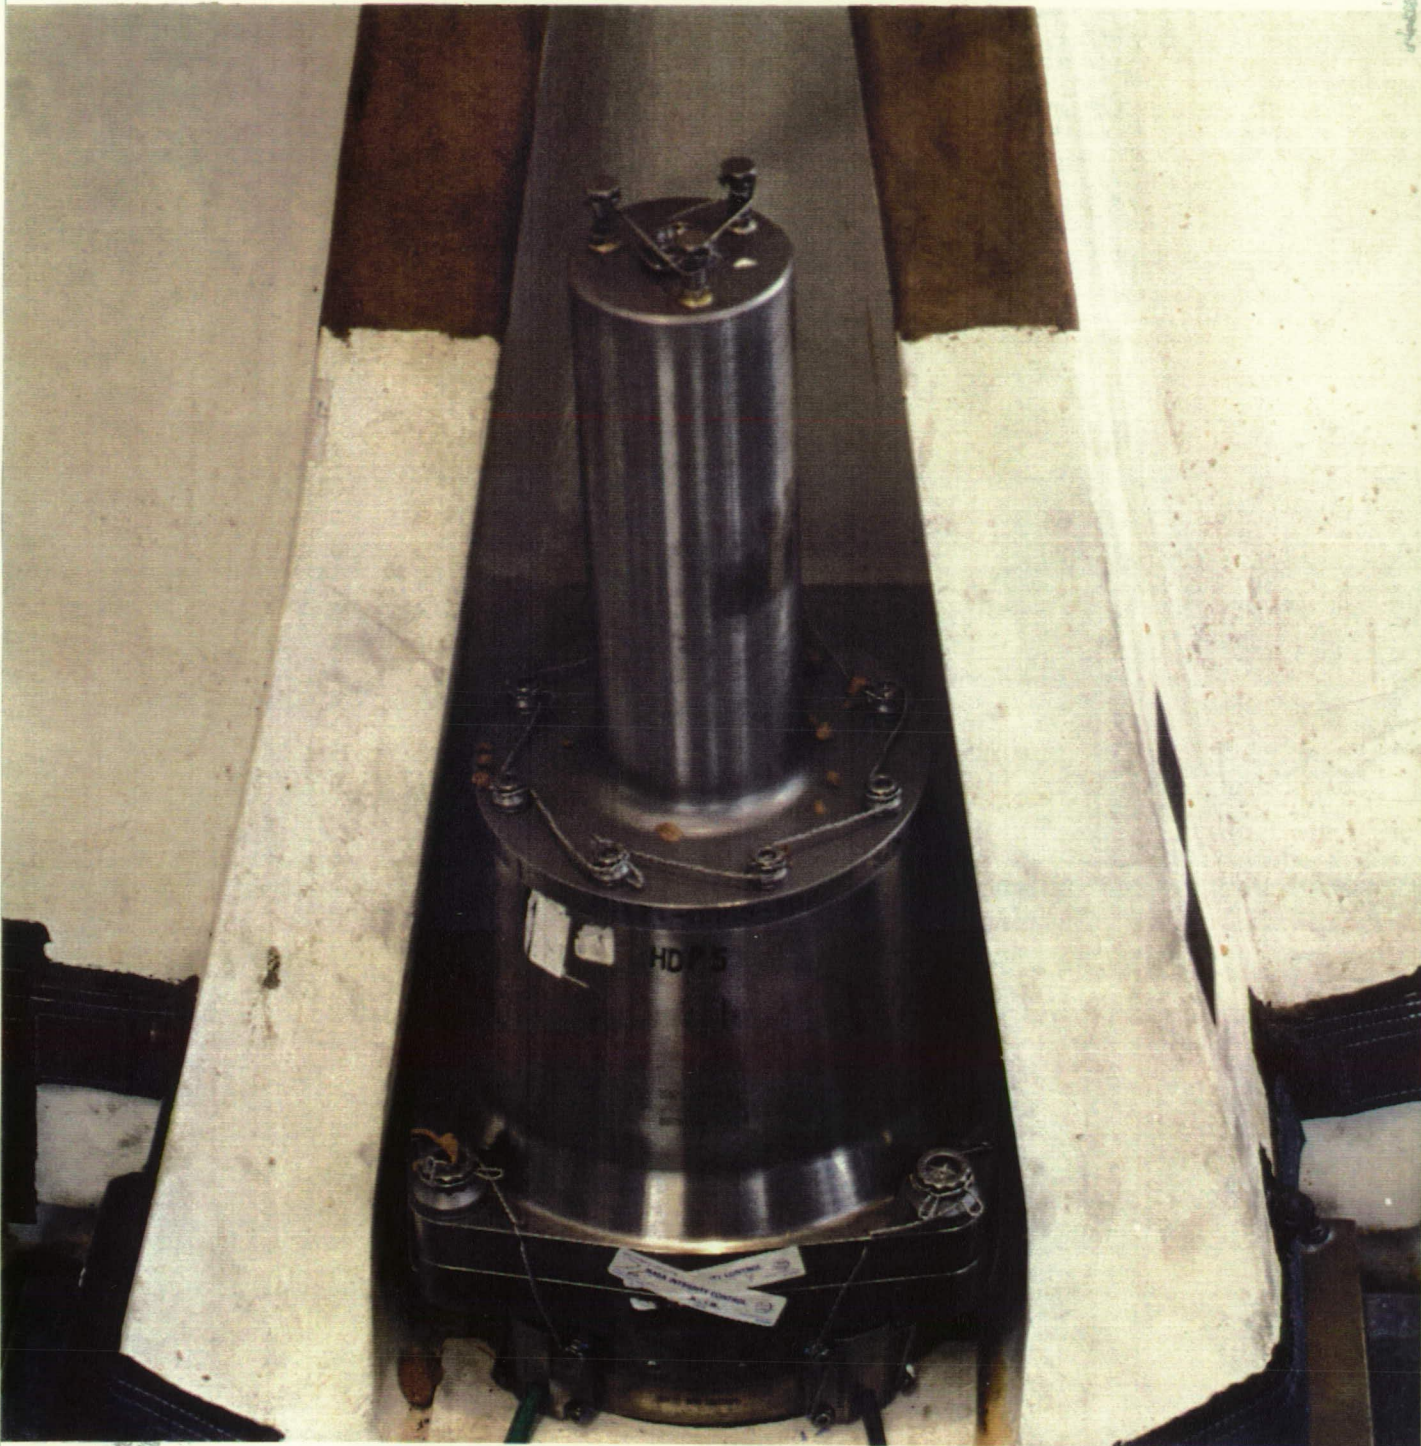
K5NA trimmings were present on the HDP #1 and #5 DCS housings, holddown posts, and haunch areas

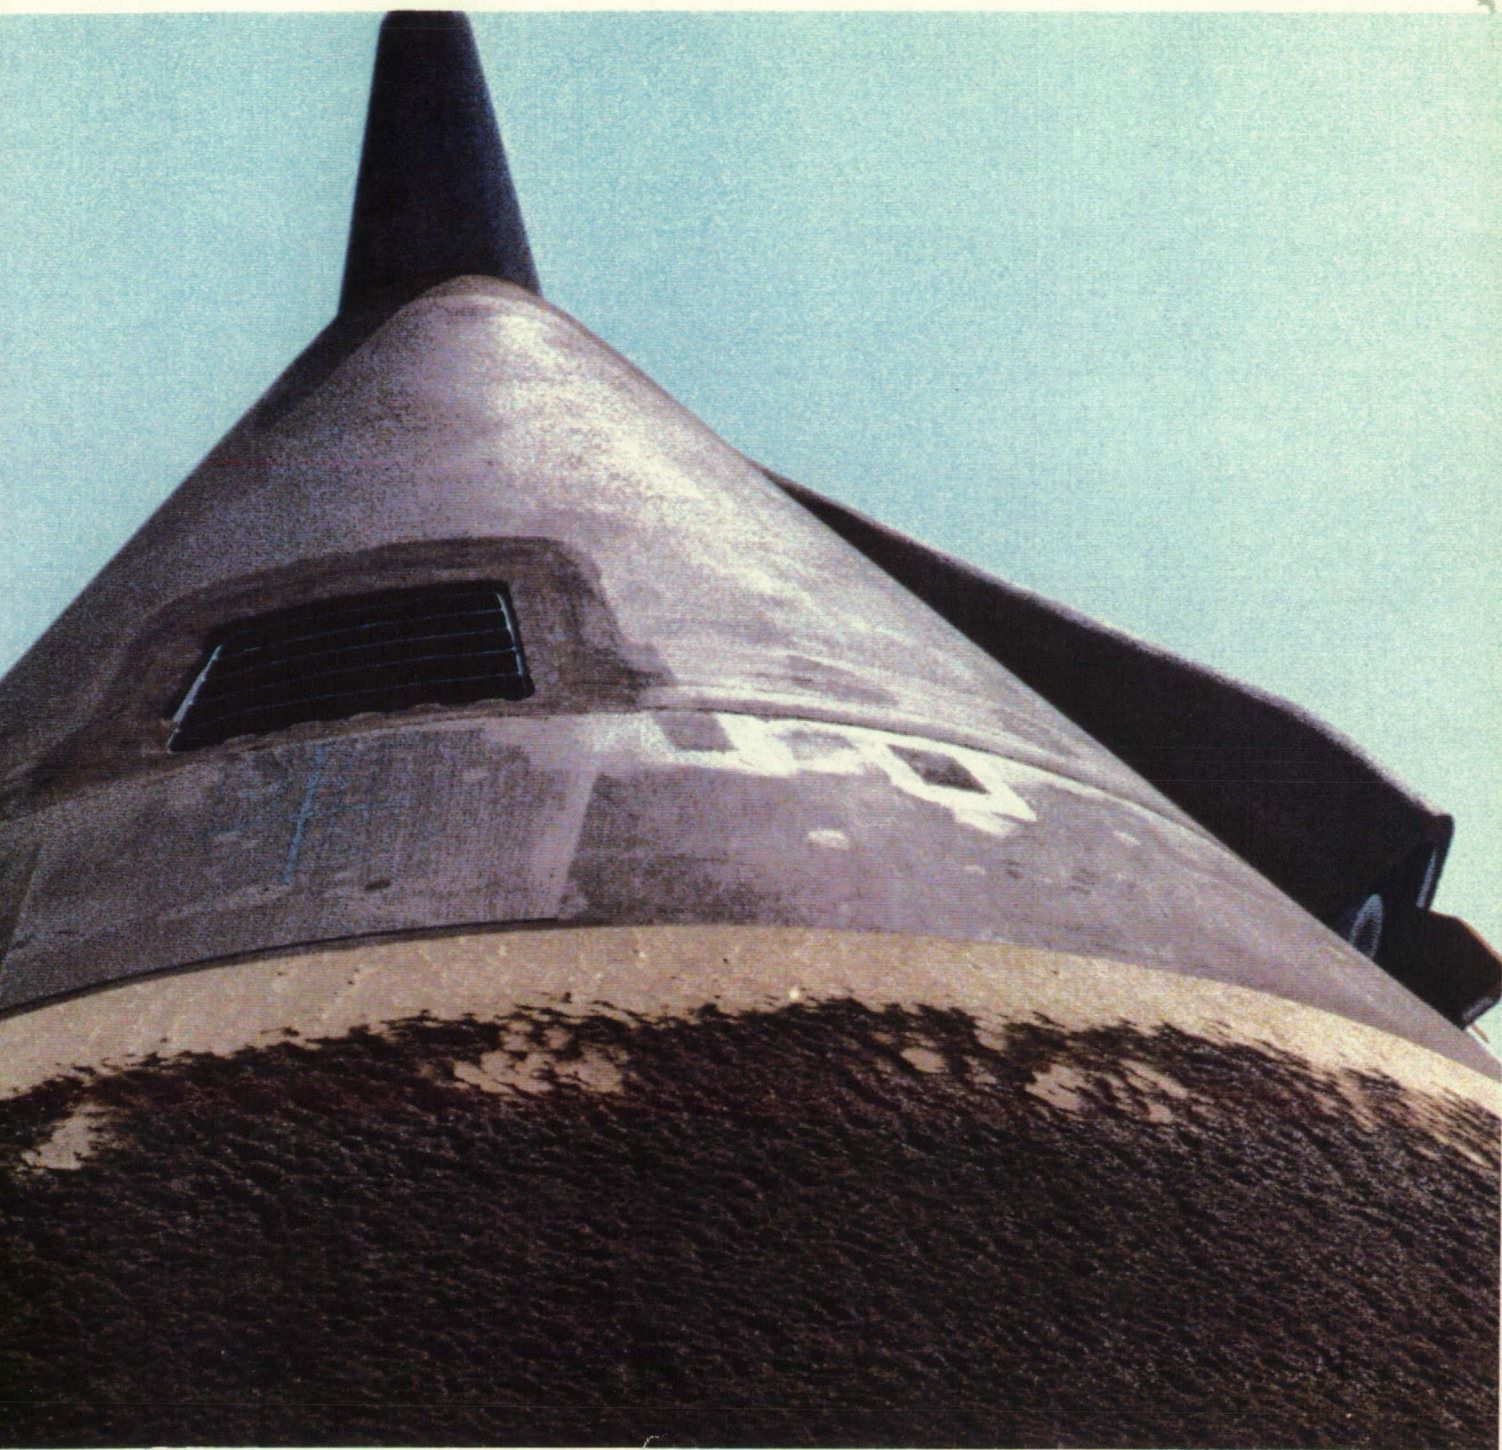
The tumble valve cover was intact. There were no anomalies on the nosecone, fairing, louver, and footprint areas.

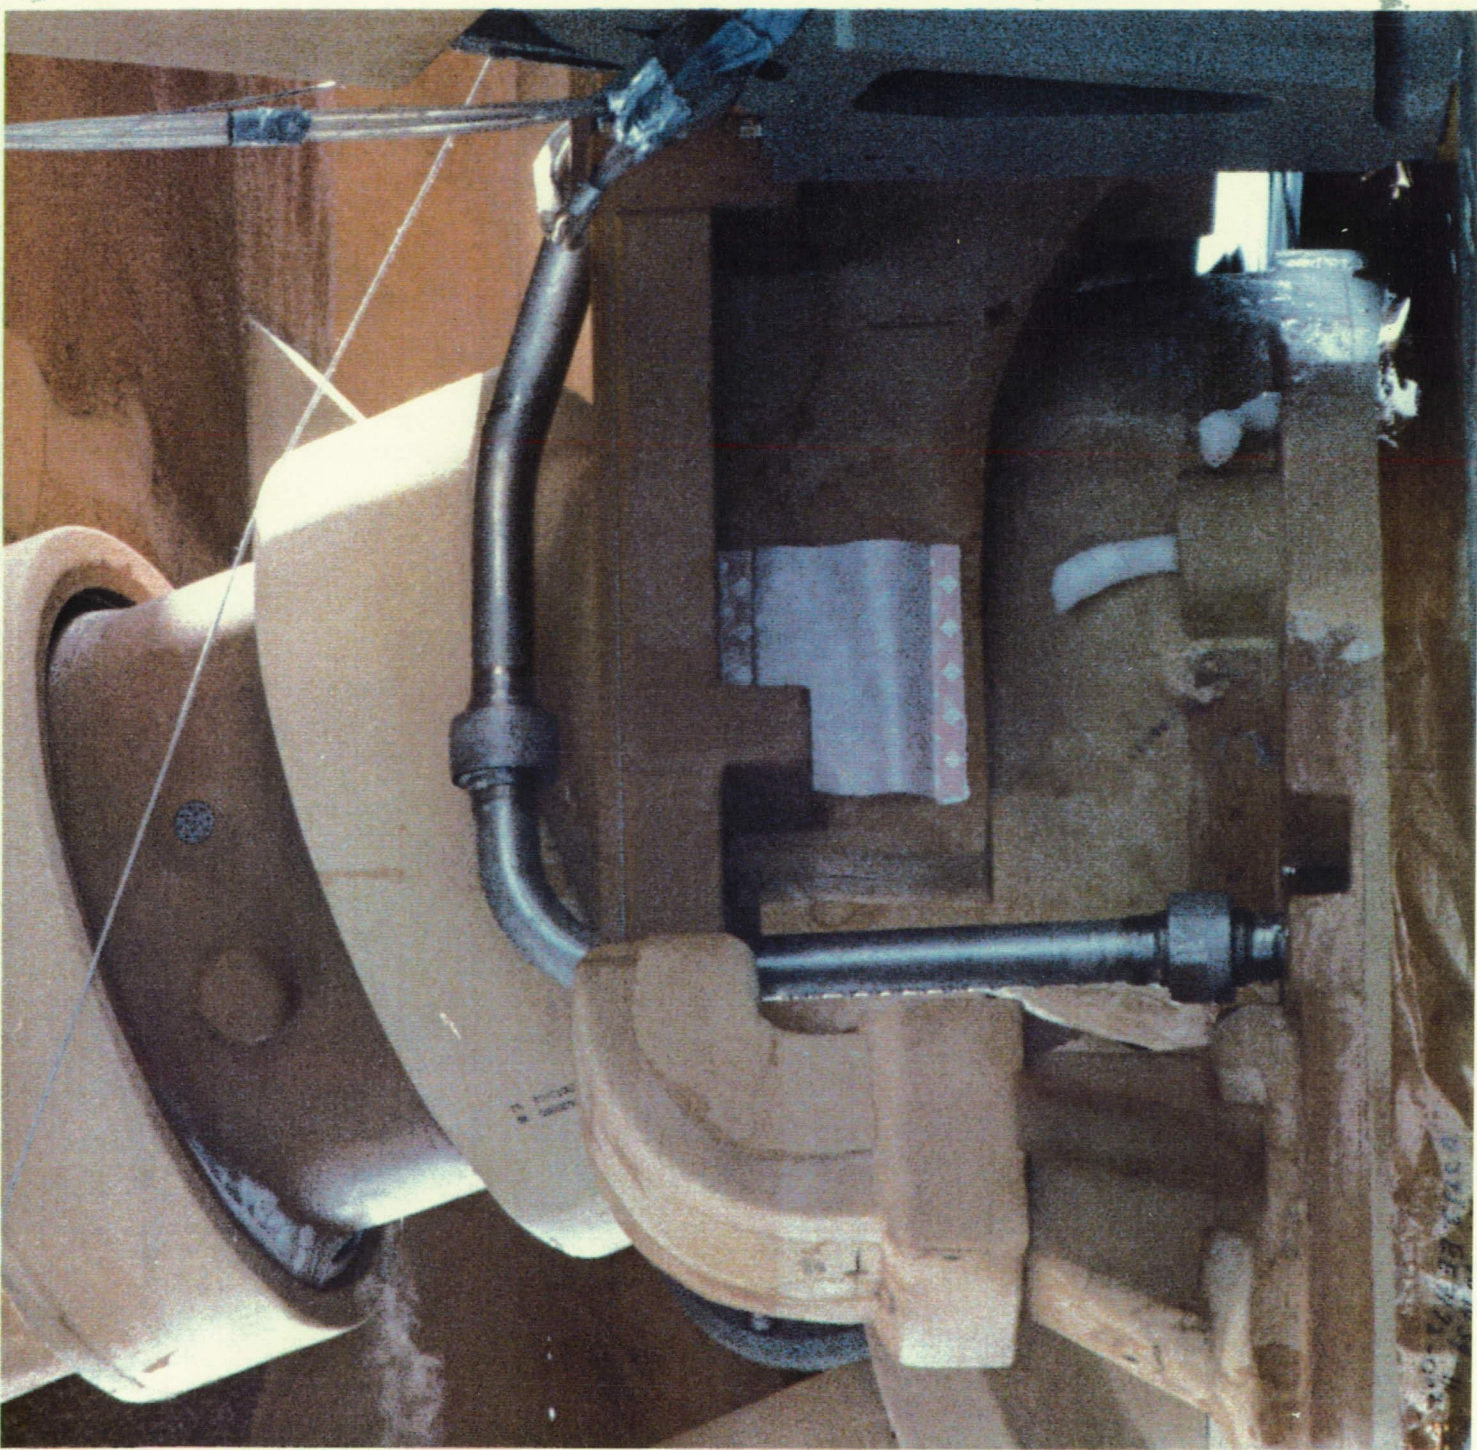
The LH2 ET/ORB umbilical exhibited no TPS anomalies or unusual ice/frost formations. Some ice remained in the LH2 feedline bellows

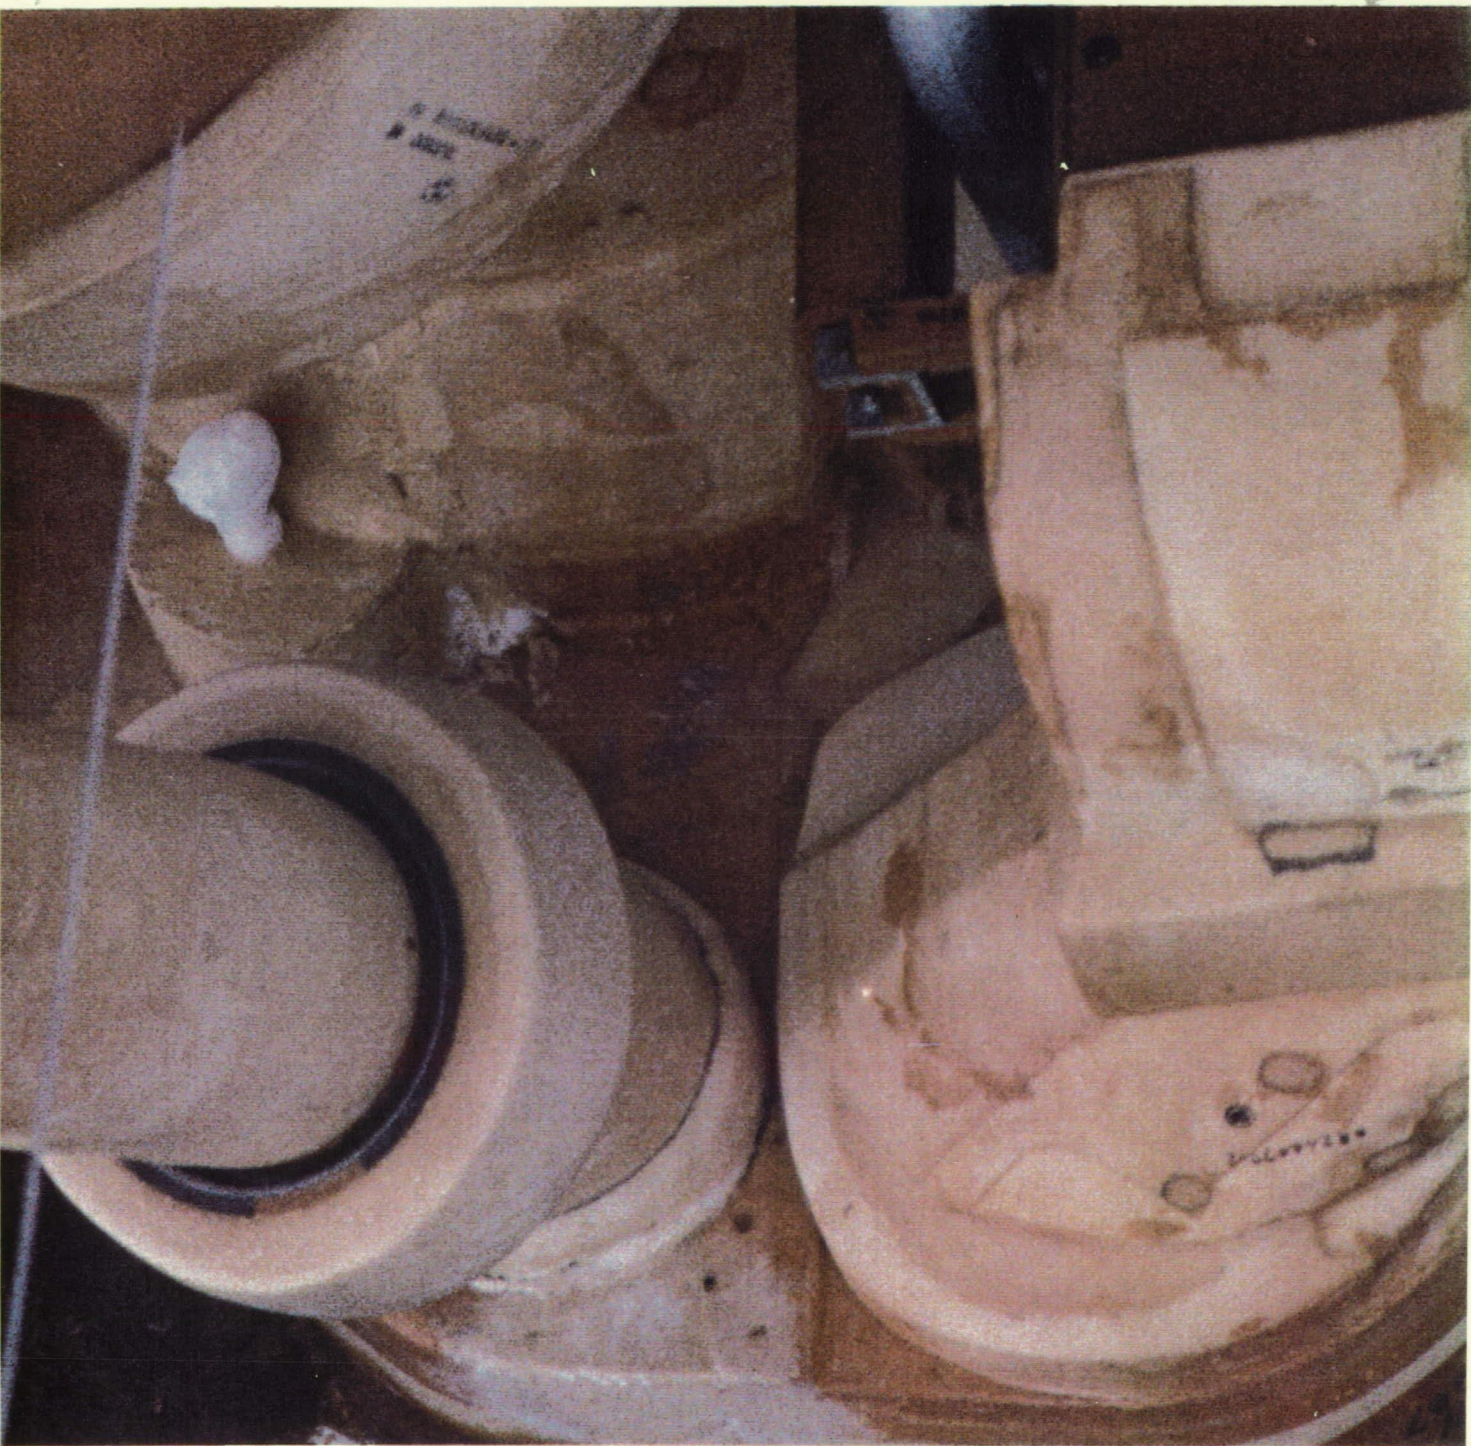
The LH2 ET/ORB umbilical exhibited no TPS anomalies or unusual ice/frost formations. The ice finger on the aft pyro canister was typical. There was no ice or frost on the 17-inch flapper valve actuator access port closeout.

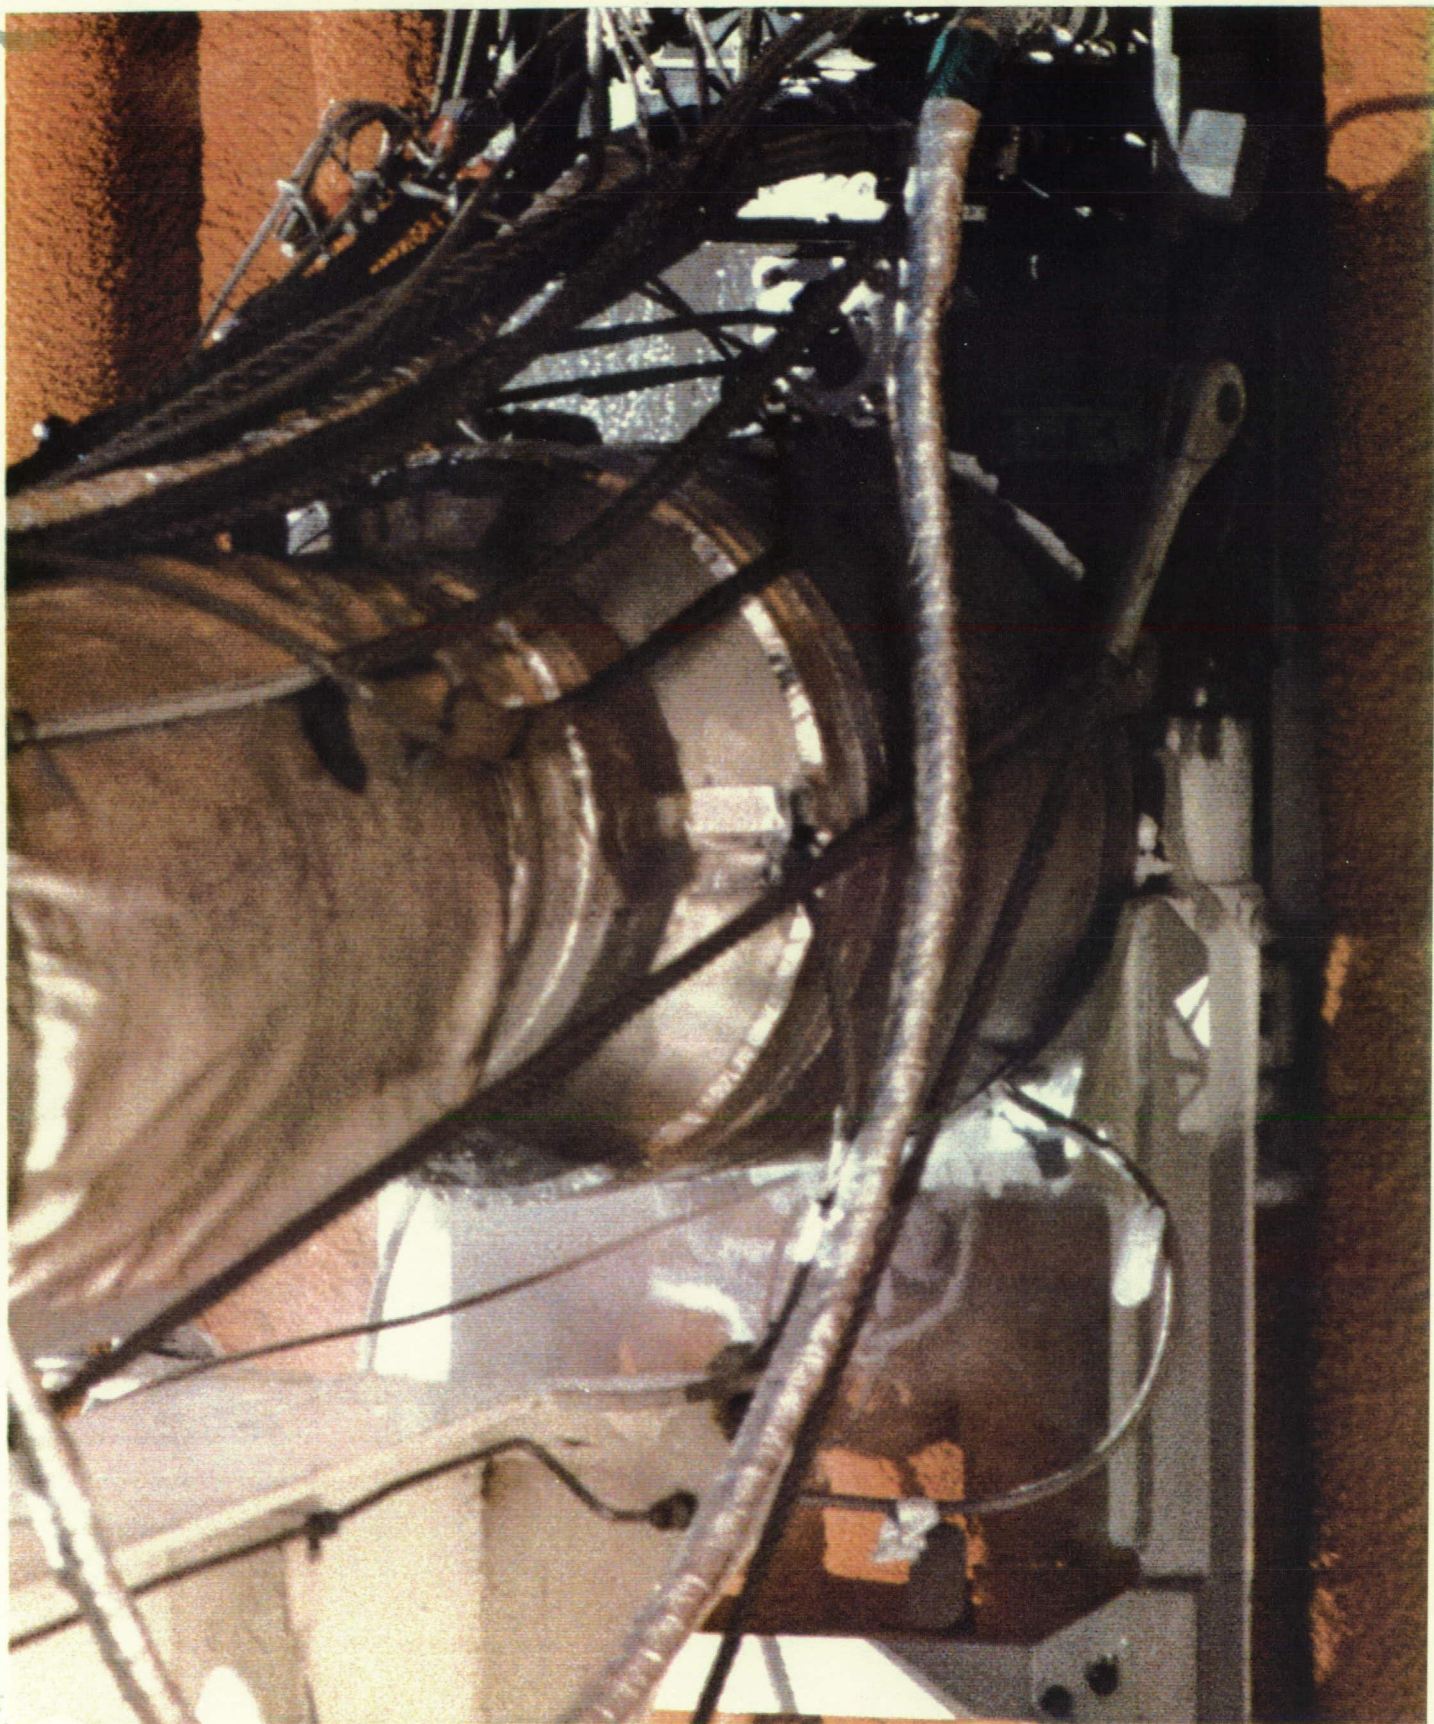
During the topping phase of hydrogen tanking, leak detectors 23 and 25 showed a rapid rise to 20,000 ppm hydrogen in the GUCP cavity purge. The leakage settled into an oscillatory pattern of 5000 ppm for a period of 7 minutes. Review of correlated ET purge data showed the hydrogen readings to be synchronous with the ET intertank (normal) purge heater cycles and the venturi (normal) differential pressure, which may suggest some unknown pressure/thermal phenomena caused the leak by distorting the cavity/QD. No hydrogen leakage was detected during the first launch attempt on 24 July 1991. Externally, there was no apparent leakage anywhere on the GH2 vent line or GUCP. The modification to the GH2 vent line prevented ice from forming, but some ice/frost, which was expected, had accumulated on the GUCP legs and on the uninsulated parts of the umbilical carrier plate.

Although leak detectors 23 and 25 showed a hydrogen leak of 5000 ppm in the GUCP cavity purge, there were no unusual vapors or ice/frost formations externally. Ice/frost accumulations on the GUCP legs and trimmed TPS areas were typical.

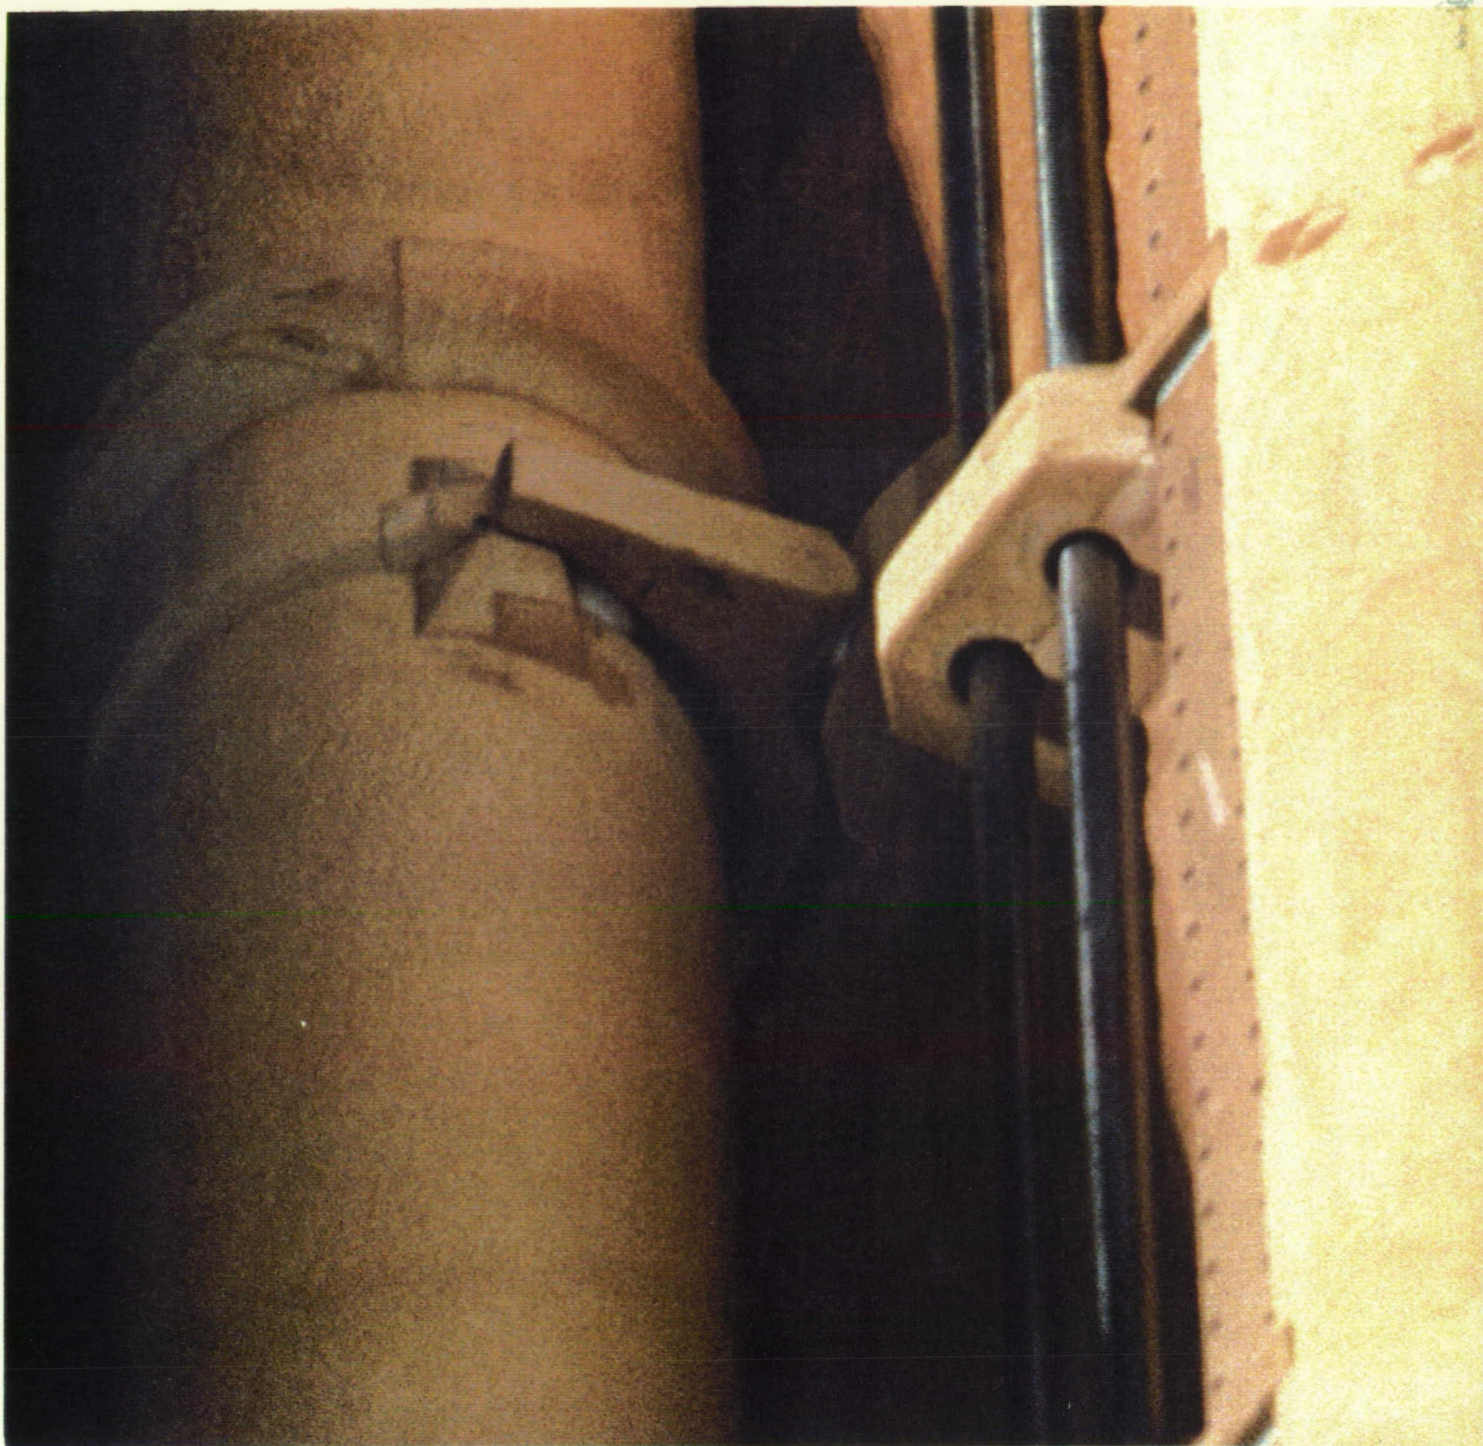
Ice/frost accumulations in the L02 feedline support brackets
were typical

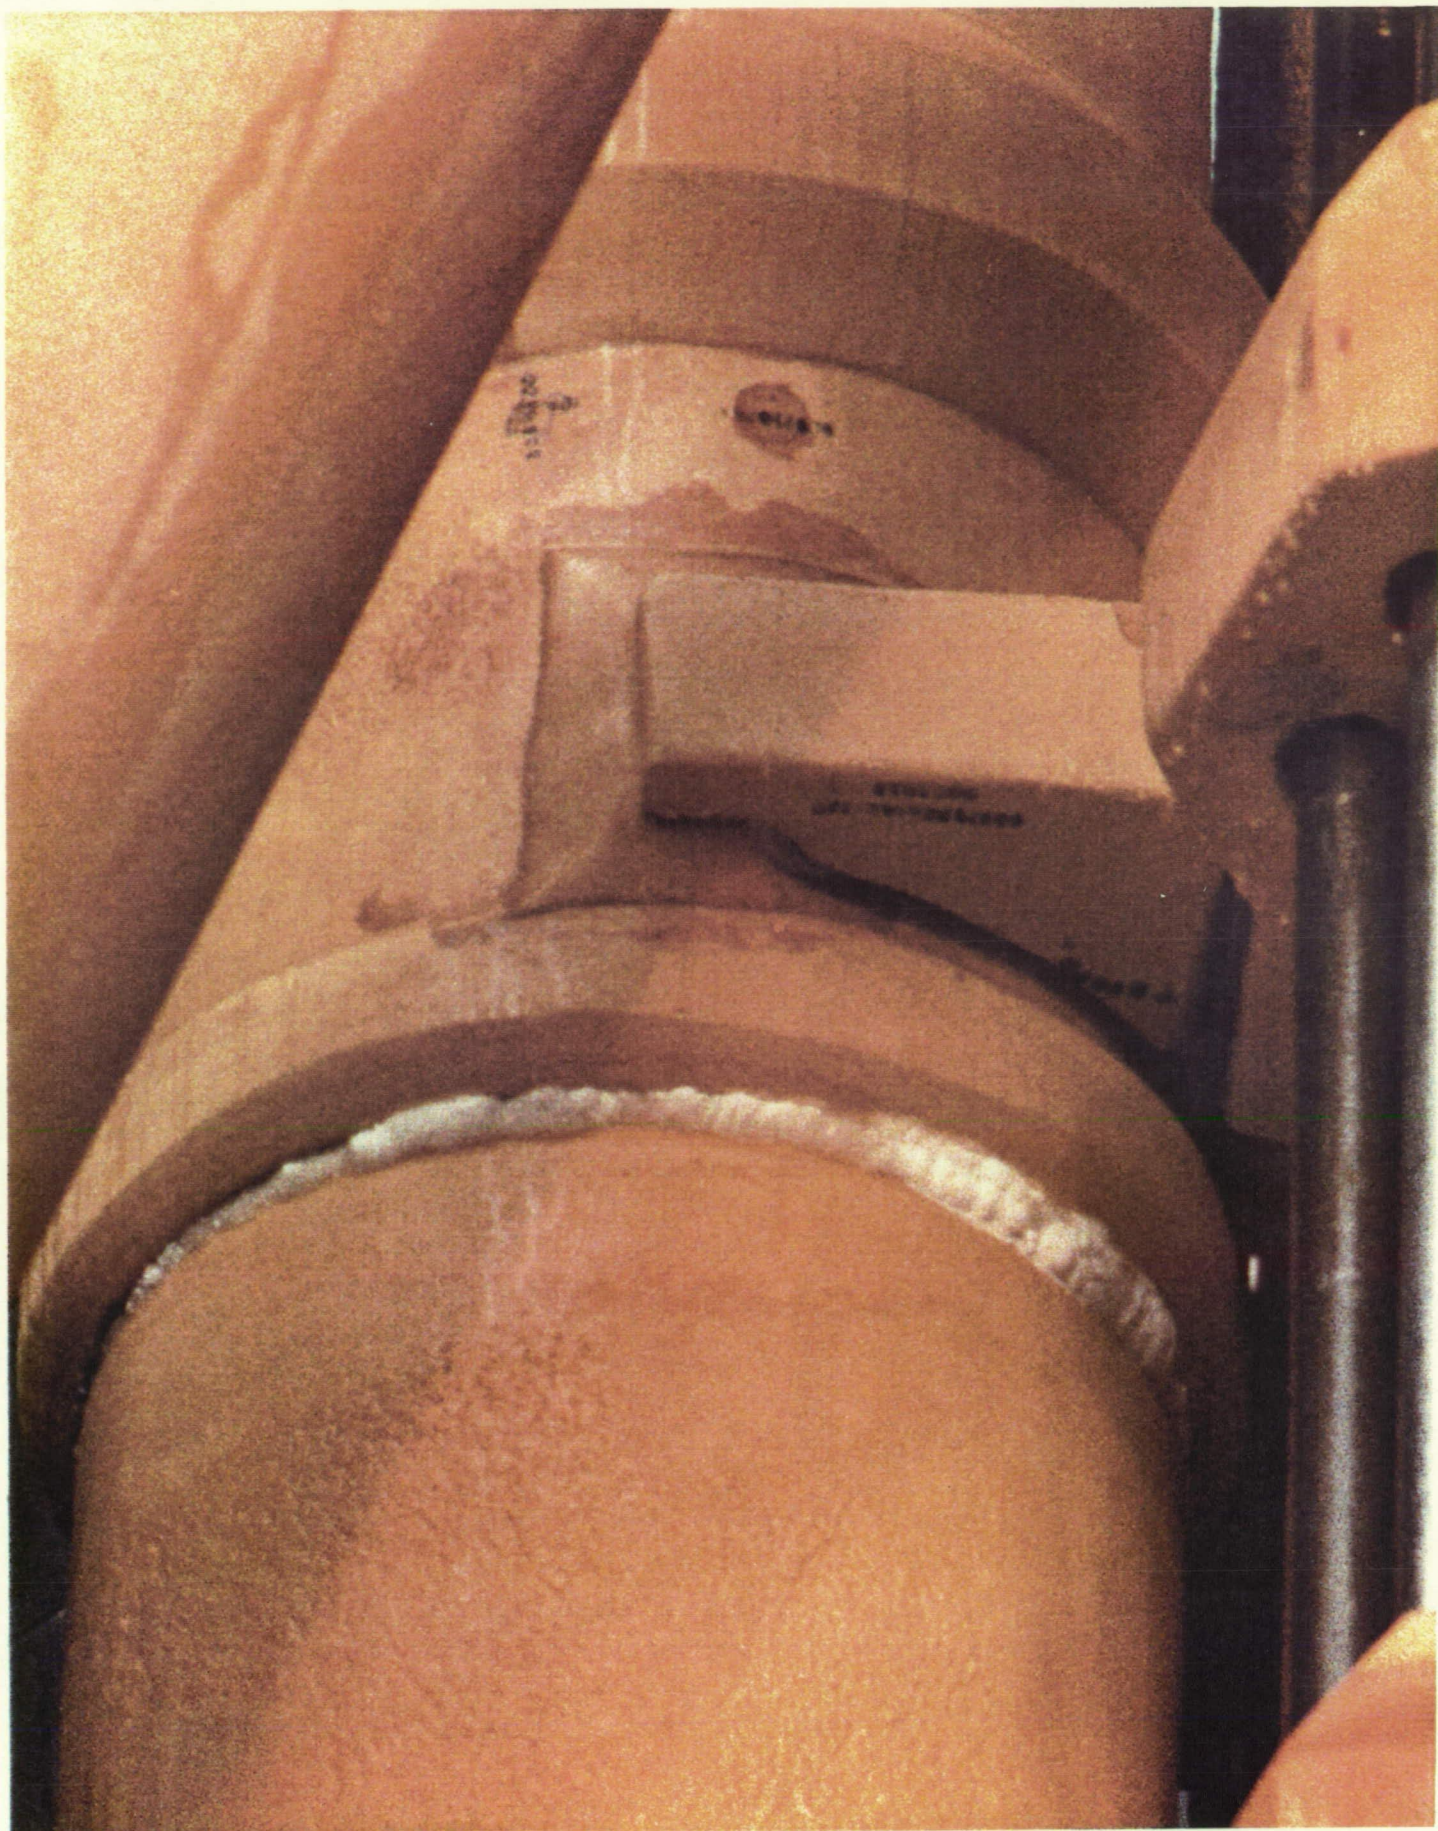
Ice/frost formations in the L02 feedline bellows were typical

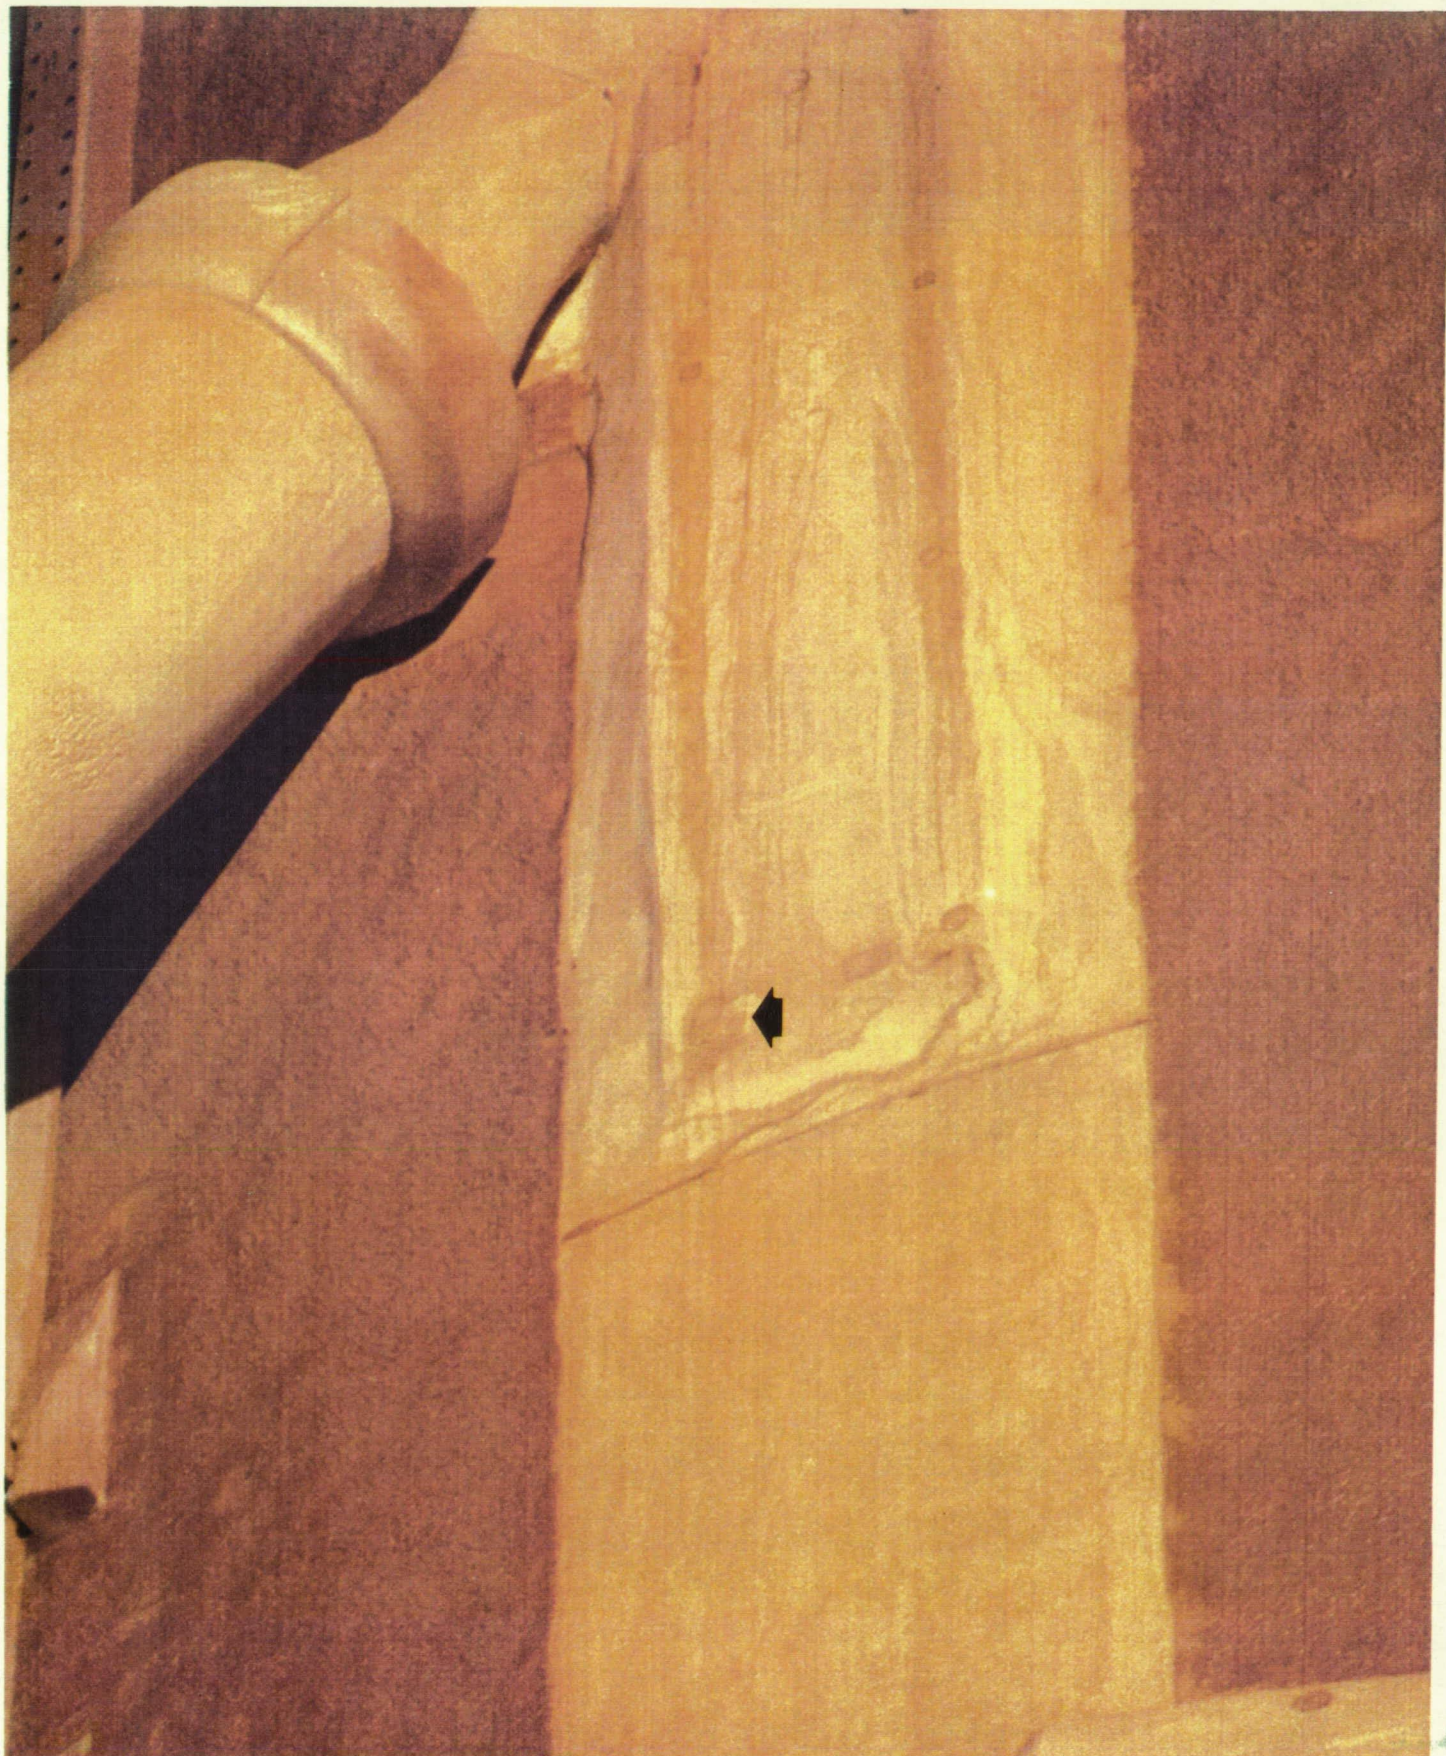
Anomaly 004 recorded two frost spots on the +Y longeron BX-250 near the aft +Z depth-gage core closeout. PR ET-47-TS-0020 was taken against a 1.5"x1" delamination along the foam knit line with 1/8-inch offset. The area was accepted by MRB approval for unrestricted use-as-is.

A 1.5"x1" area in the +Y longeron BX-250 adjacent to the aft +Z depth-gage core closeout, though protruding with an 1/8-inch offset, formed no ice/frost during cryo load. An MRB approved the condition for flight based on acceptance criteria in NSTS-08303.

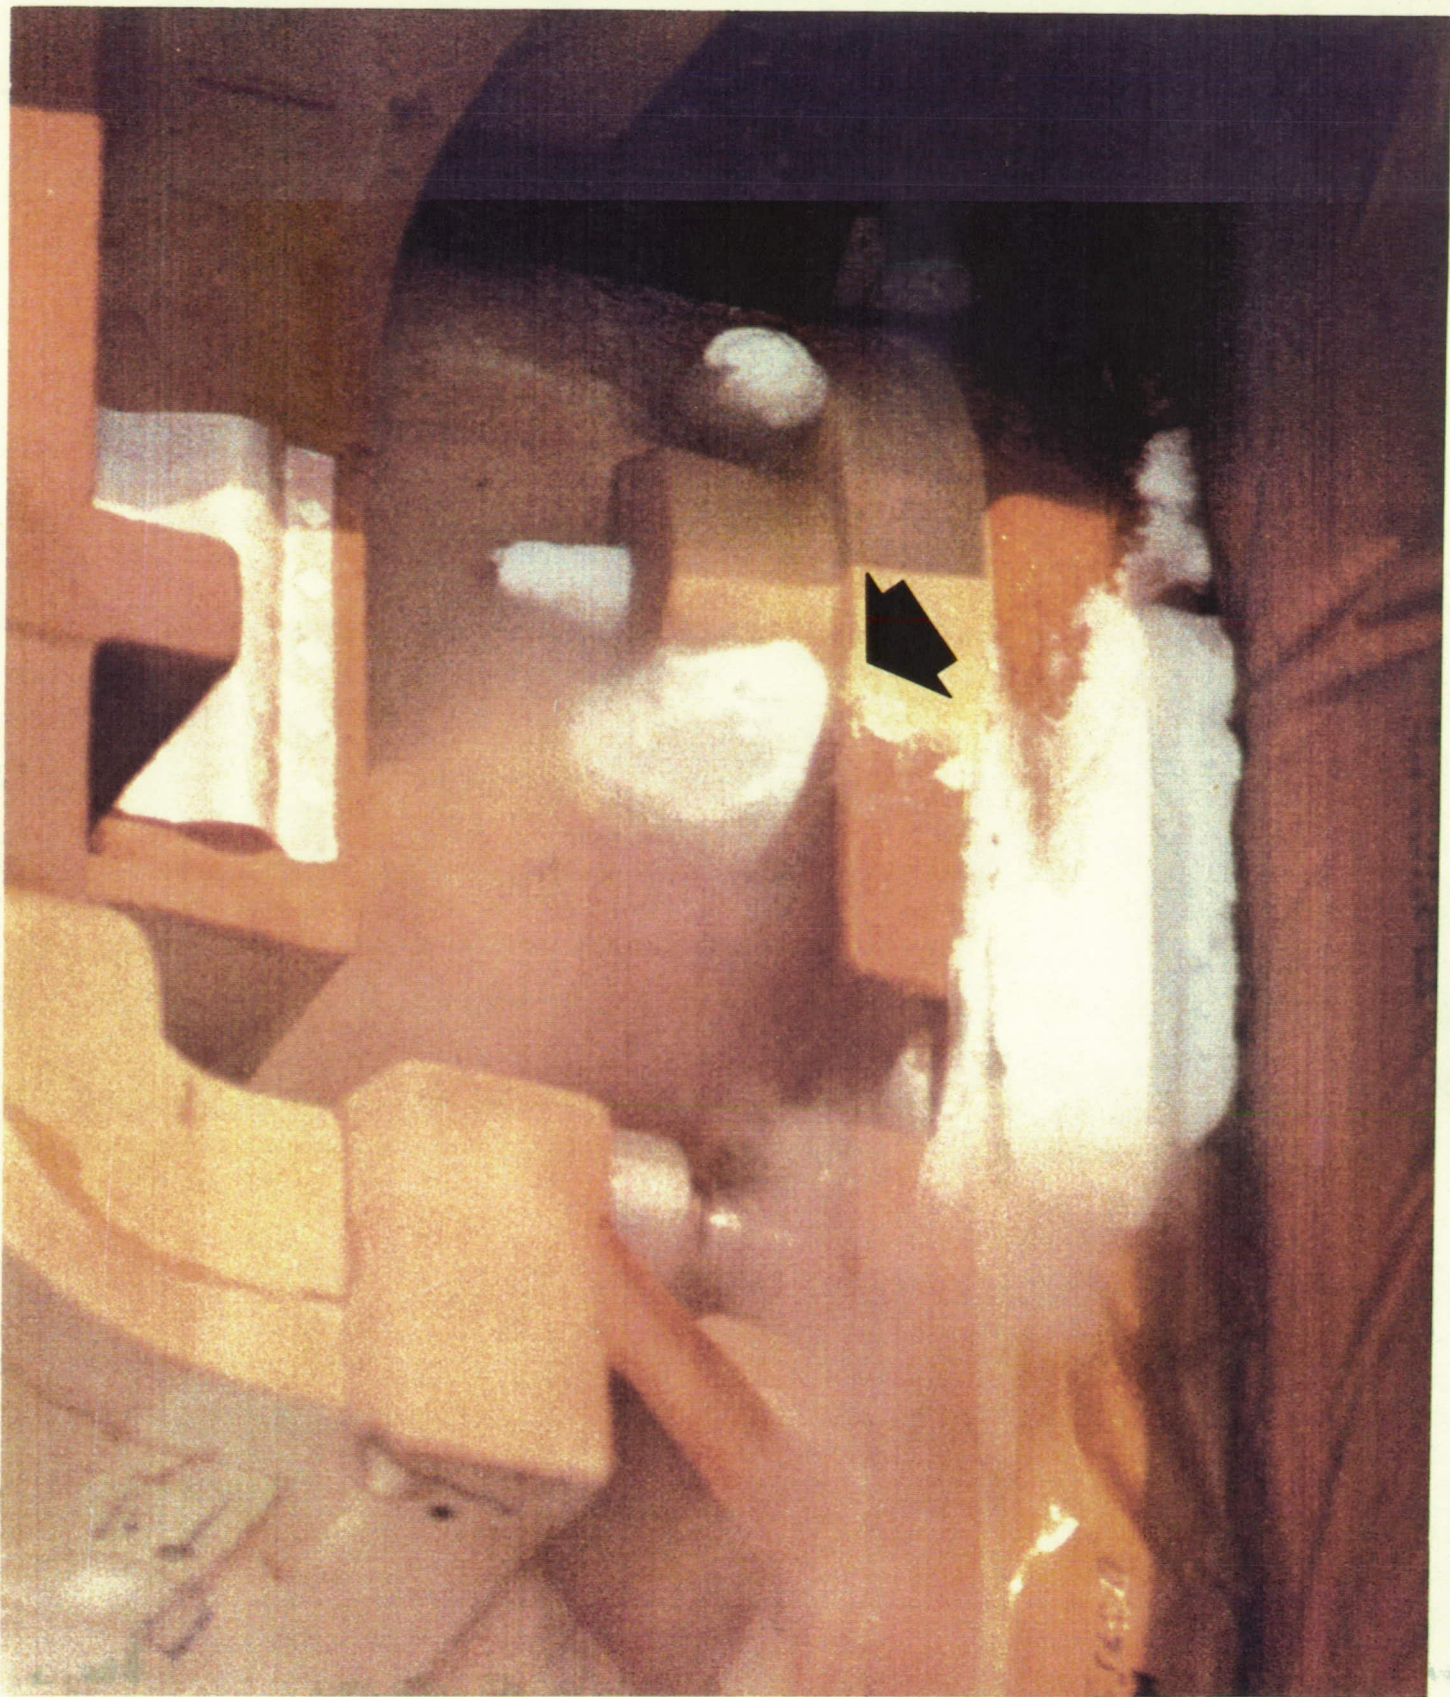
Ice/frost accumulations on the LH2 ET/ORB umbilical outboard side and top sides, plate gap purge vent, and forward outboard pyrotechnic canister purge vent were typical. A small amount of ice/frost had formed along the bondline of the pyro canister closeout (aft side) - an acceptable condition per NSTS-08303.
